No: PB 106
April 15th, 2008

Flame Guard®

Pilot Assembly Replacement Kit. P/N 186800-000

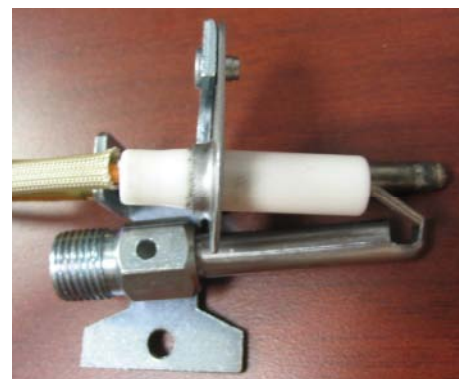
- A larger pilot orifice which results in a 25-30% stronger pilot flame to resist high winds.
- A wider gap between the pilot and thermocouple for improved mV thermocouple stability.
- New thermocouple.

To assist in reducing service calls as a result of pilot outages caused by irregular weather conditions such as high wind, cold weather and excess condensation. GSW has created this “**Pilot Assembly Replacement kit**”.

This “**Pilot Assembly Replacement kit**” should only be installed provided all other procedures listed in (Technical Bulletin)TB-116 “**Flameguard® Pilot Outage Checklist**” have been completed and verified.
